Damage and Vulnerability Analysis of Debris Slide Impacts to Buildings through Analytical Methods

AARON ORR
March, 2019

Thesis submitted to the Faculty of Geo-Information Science and Earth Observation of the University of Twente in partial fulfilment of the requirements for the degree of Master of Science in Geo-information Science and Earth Observation.

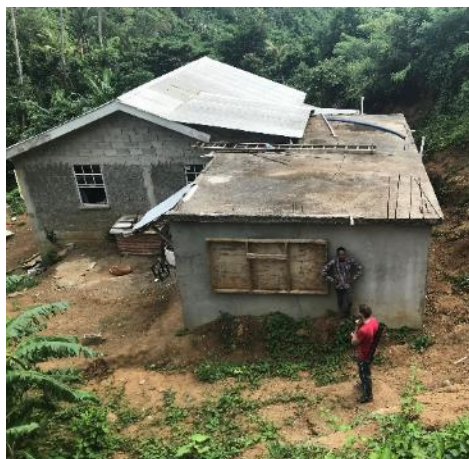
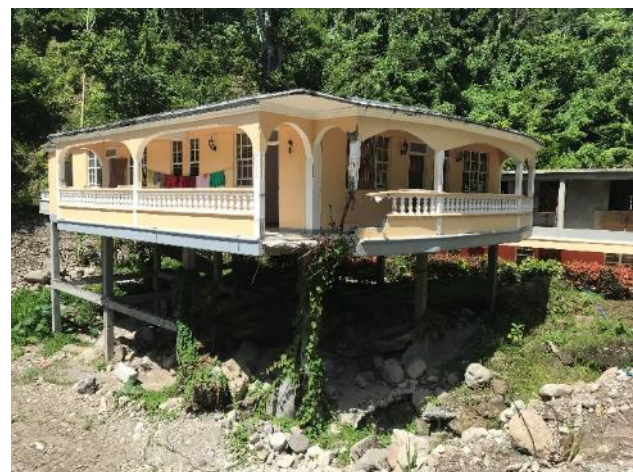
Figures 3.3 & 3.4: (Left) Single story concrete block building affected by a debris slide; (Right) single-story building, raised on a reinforced concrete frame, affected by debris flows and a sediment stream.

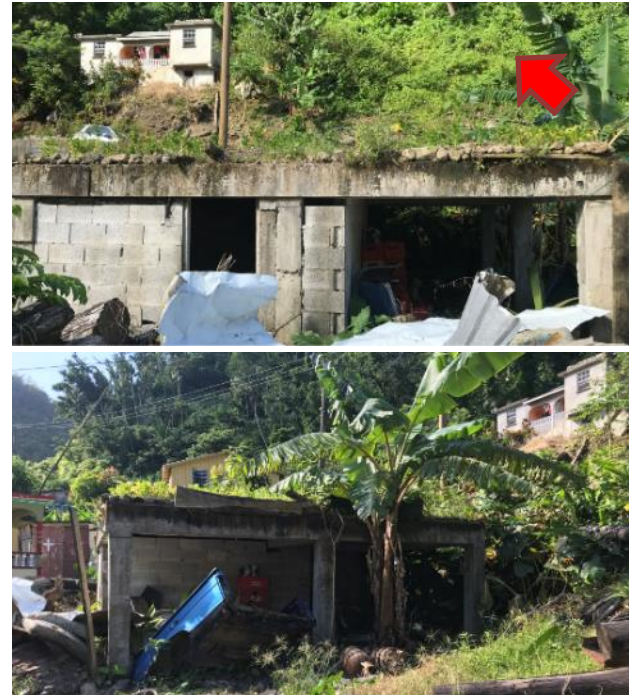
Figure 3.6 & 3.7: (Top) Building 1 is missing an additional timber framed second-story, and the debris slide mobilised from across the road identified by the red arrow; there is a car parked on the road below building on the hill. (Bottom) Side profile of Building 1; there are cracks visible where the walls do not touch the frame or ceiling slab, and debris accumulated around the buildings

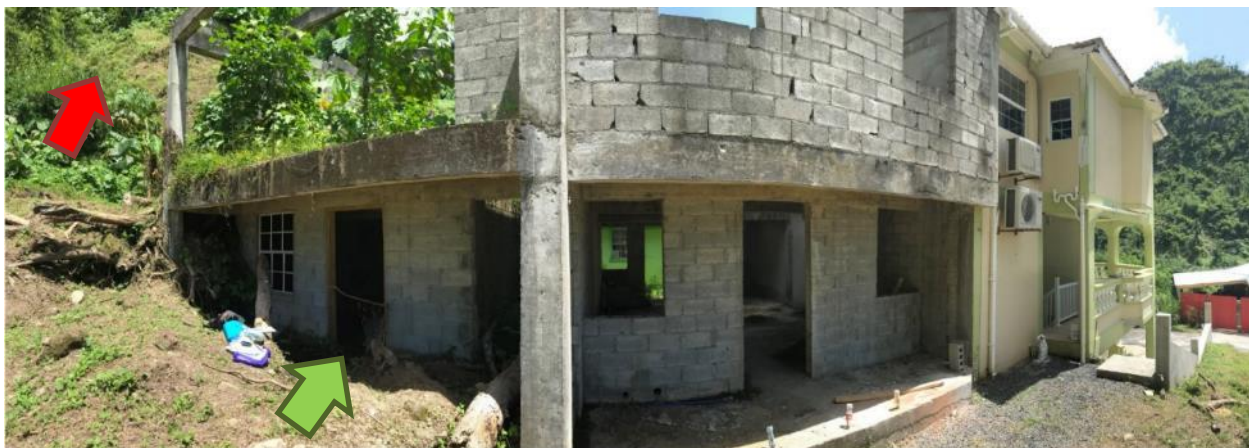
Figure 3.10: Debris source indicated by the red arrow; green arrow points to the flooded room in Figure 3.11

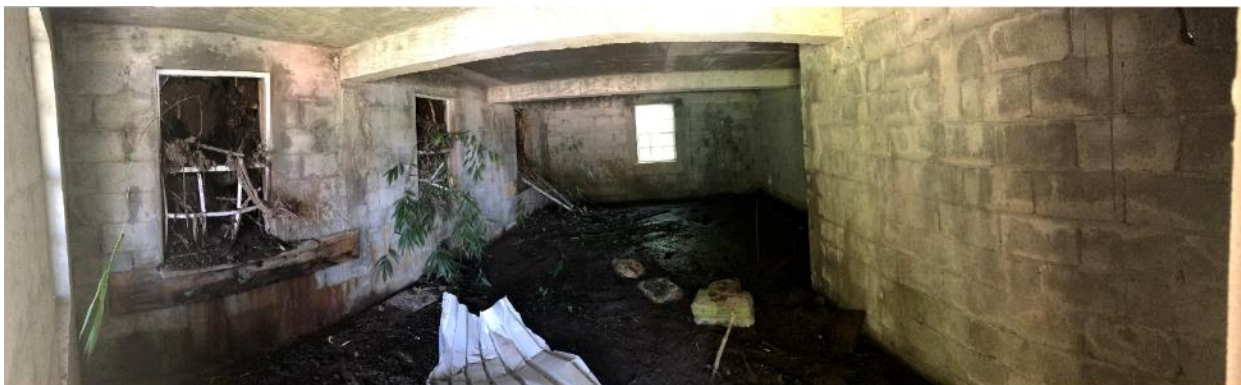
Figure 3.11: Flooded room with debris in the windows resulting in an even layer of soil in the room

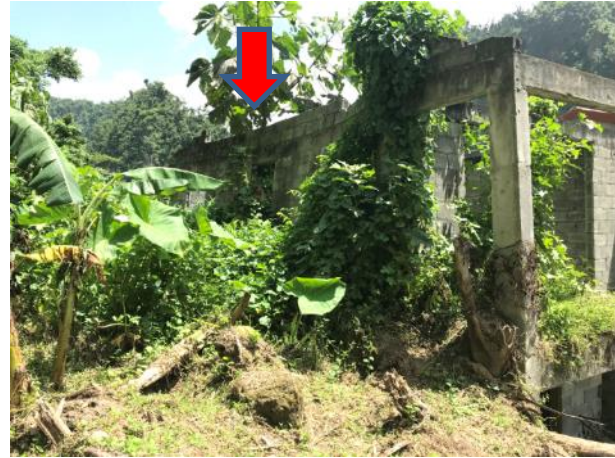
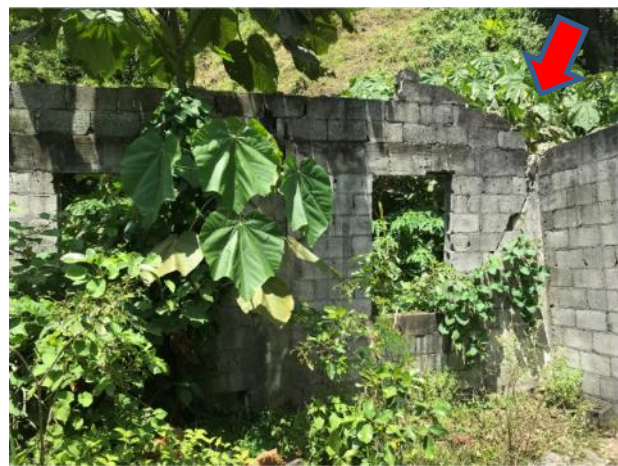
Figure 3.12 & 3.13: (Top) The second-floor of the affected wall on Building 2 was buckling at the red arrow from the accumulated debris; (Bottom) the affected wall and frame was cracked, at the red arrow, due to debris in Figure 3.12

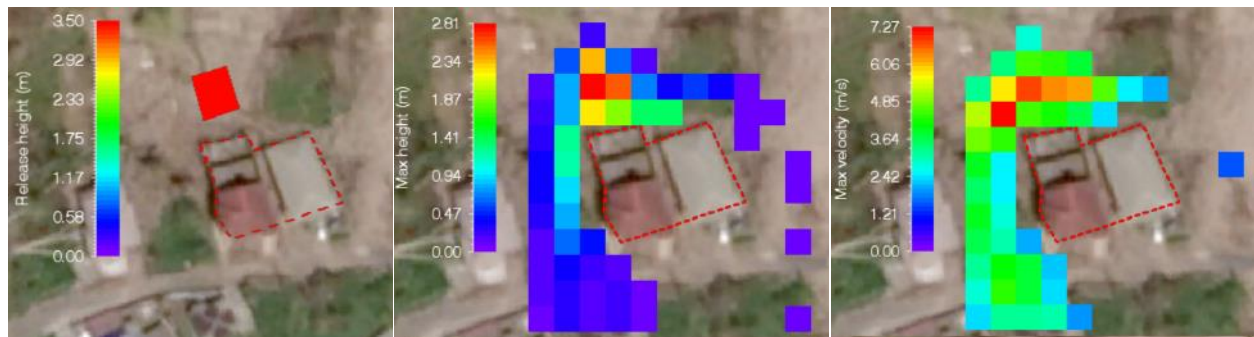
Figures 4.4– 4.6: (Left) The release depth was adjusted to 3.5 meters; (Center) simulation results in a max debris height of 2.81 meters and 2.0 – 2.5 meters of debris against the building; (Right) The velocity distribution shows a max flow velocity of 7.27 m/s and 4.85 m/s against the affected facade of Building 2.

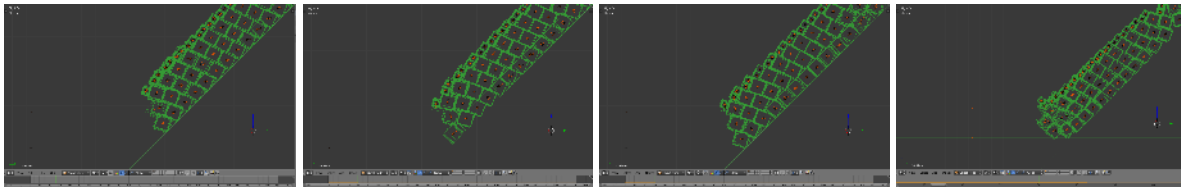
a) Surface Response 1.0 b) Surface Response 0.8 c) Surface Response 0.5 d) Surface Response 0.3

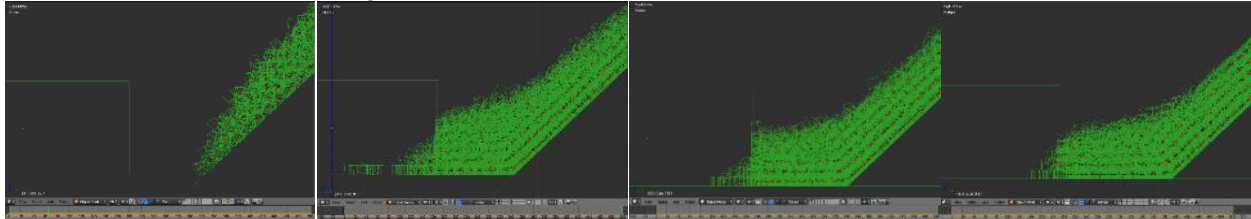
Figures 4.16a, 4.16b, 4.16c, 4.16d are presented left to right respectively: A relatively uniform distribution of soil-elements approached the building after the surface response was adjusted to 0.5; (4.21b) the distance modelled between the building and hillslope was adjusted to 4.0m which resulted in a simulated height of ~3.5m against the building. (4.21c) The distance between the building and the hillslope was adjusted to 5.0m, and the simulated accumulation height of soil-elements resulted in ~3.0 meters; (4.21d) at a distance of 6.0 meters the simulated accumulation height of soil-elements against the building reduced to ~2.5 meters. How to adjust distance video available at: https://www.youtube.com/channel/UCII_8TbvAsG2BZJENUtjcvq

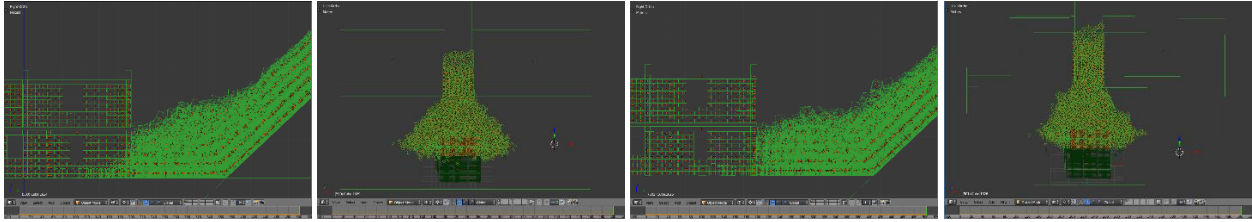
Figures 4.18a, 4.18b, 4.18c, 4.18d are presented from left to right respectively: Figure 4.23a & 4.23b present the simulation results with a 5.0m distance between the house and the hillslope. The simulation resulted in nine soil-elements entering the building, through the windows, on the ground floor. The simulated height of soil-elements against the building was $\sim 2.5\text{m}$ and the middle window of the ground floor was covered, the same as observed during fieldwork. Figure 4.23b presents the front view of the results. Figure 4.23c presents the simulation results with a 6.0m distance between the building and the slope. The geometry was relatively more level between the building and the slope than Figure 4.18a, and the accumulated debris against the building was $\sim 2.5\text{m}$ the same as observed during fieldwork. Figure 4.23d presents the front view using a 6.0m distance and more of the landslide remained on the hillslope. Passive rigid body building video available at: https://www.youtube.com/channel/UCII_8TbvAsG2BZJENUtjcvq

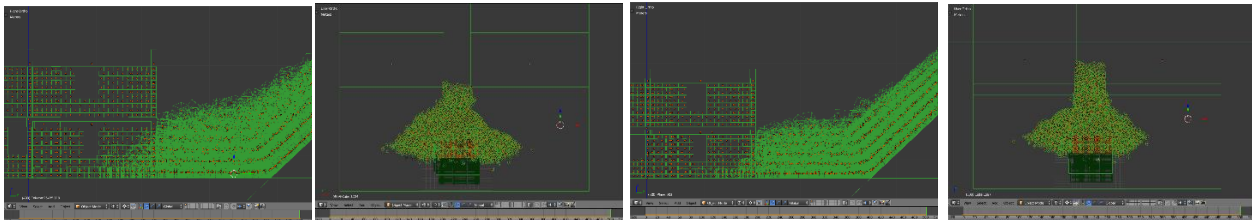
Figures 4.19a, 4.19b, 4.19c, 4.19d are presented from left to right respectively: Figure 4.19a & 4.19b present the simulated results with a 5.0m distance between the house and the hillslope. The simulated accumulation of soil-elements against the building was $\sim 2.6\text{m}$, two of the ground floor windows were covered, and 10 soil-elements entered the building through the windows on the ground floor; additionally, a surface response of value 0.3 for the hillslope resulted in less mass on the hillslope; Figures 4.19c & 4.19d present the simulated results with a 6.0m distance between the house and the hillslope. The simulated accumulation of soil-elements against the building was $\sim 2.5\text{m}$, and the tops of the ground floor windows were visible from outside the building; however, the simulated accumulation geometry between the building and hillslope has a relatively higher resemblance than simulation results using a 5.0m distance between the building and the hillslope. Passive rigid body building video available at: https://www.youtube.com/channel/UCII_8TbvAsG2BZJENUtjcvq

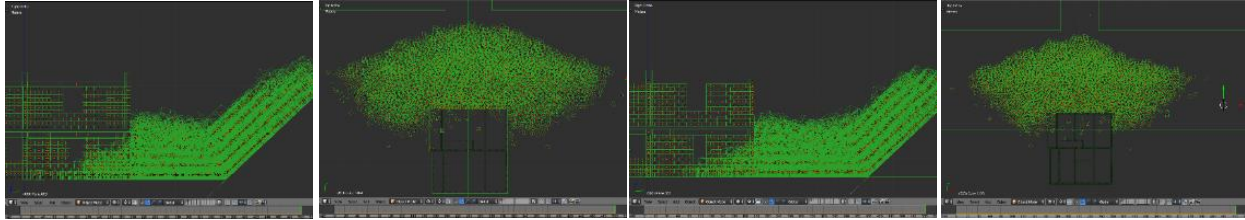
Figures 4.20a, 4.20b, 4.20c, 4.20d are presented from left to right respectively: Figure 4.20a & 4.20b present the simulated results with a 5.0m distance between the house and the hillslope and a hillslope surface response value of 0.0. The simulated results significantly improve in resemblance of the debris accumulated against the building and between the building and the hillslope relative to the observed accumulation during fieldwork. The simulated accumulation height against the building, using a 5.0m distance, is ~3.0m and 12 soil-elements enter the building through the ground floor windows. Figures 4.20c & 4.20d present the simulated results with a 6.0m distance between the house and the hillslope. The simulation resulted in an accumulation of soil-elements ~3.0m high against the building, 10 soil-elements entering the building through the ground floor windows, and one soil-element entering the building through the centre window of the second floor. Passive rigid body building video available at: https://www.youtube.com/channel/UCII_8TbvAsG2BZJENUtjcvg

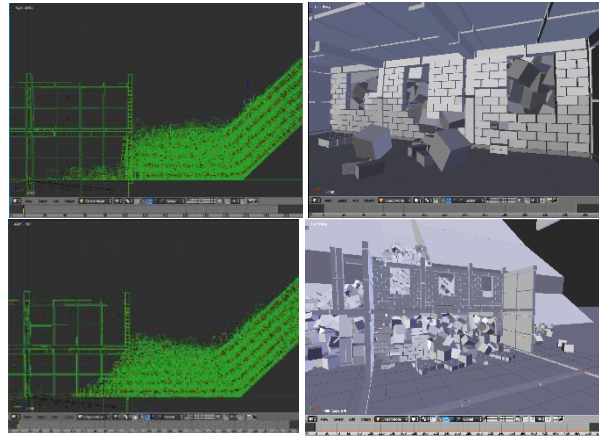
Top Figures 4.23 – 4.24: (Top) Discretising the unaffected walls affects the deposit geometry and damage. Figures 4.25 – 4.26: (Bottom) Increasing the length of the simulation run-time resulted in more damage occurring later in the event. Damage Video available at: https://www.youtube.com/channel/UCII_8TbvAsG2BZJENUtjcvg

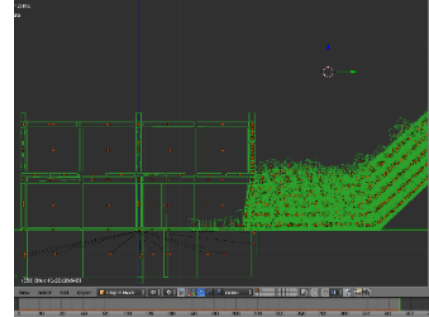
Figures 4.27: Presented is simulation result using a 10.0m discretisation of the unaffected walls; the affected wall was observed shearing less, in comparison to the Figure 4.25.

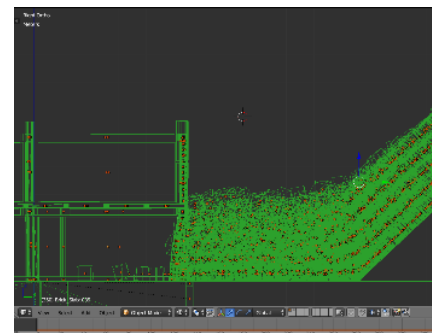
Figures 4.28: Presented is the simulation result using full concrete slabs for the unaffected walls; the affected wall was observed shearing relatively the same amount as Figure 4.27. Damage Video with replaced walls available at:

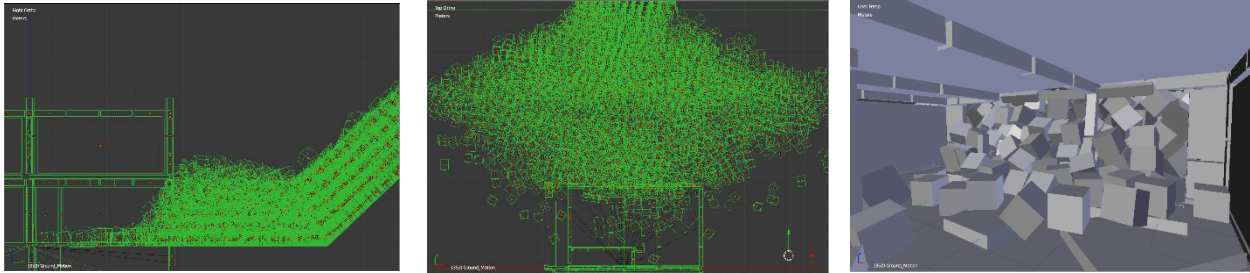
Figures 4.34 – 4.36: (Left 4.34) The simulation result after increasing the shear and bending breaking thresholds to 1.0 N/mm^2 modelled an accumulation height of ~ 2.75 meters; (Centre 4.35) the simulated geometry of the deposit was relatively similar to the site assessment; (Right 4.36) however, increasing the shear and bending breaking thresholds do not significantly decrease the degree of damage to the house. Damage video available at: https://www.youtube.com/channel/UCII_8TbvAsG2BZJENUtjcvg

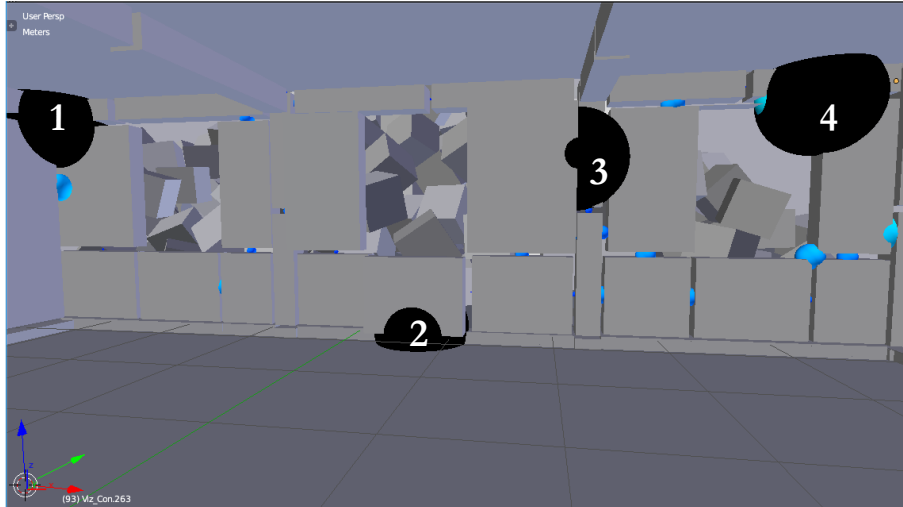
Figure 4.38: Presented is the moment the first constraint breaks from the impact; the constraints, where connecting elements model the breaking thresholds, 1 & 4 break before the impact due to the design of the model, and constraints 2 & 3 shear from the foundation of the building and the column respectively.

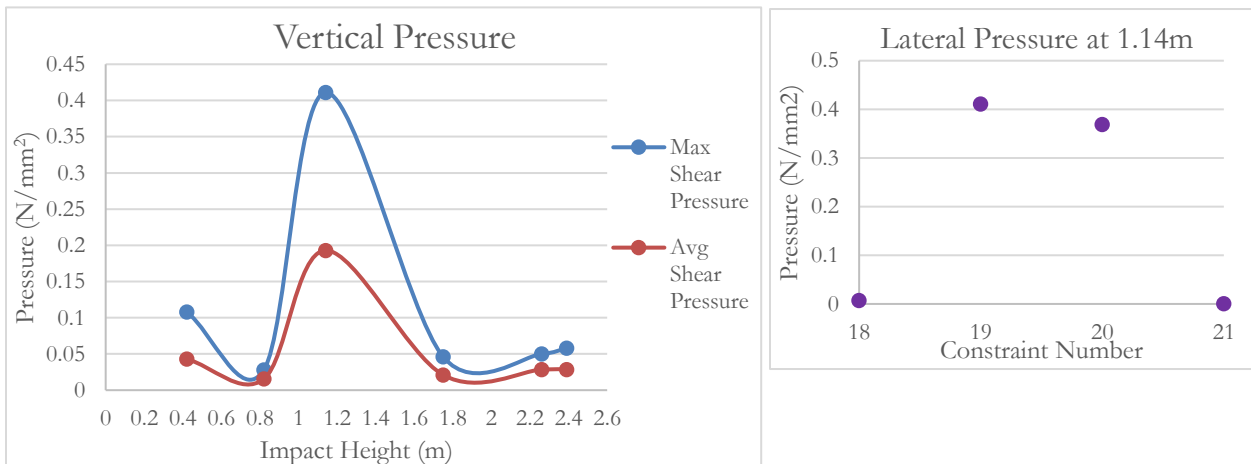
Figure 4.40 & 4.41: (Left) Presented is the vertical pressure gradient of simulated average and max shear forces on the affected wall; (Right) the lateral pressure presented shows the simulated forces on the affected wall at

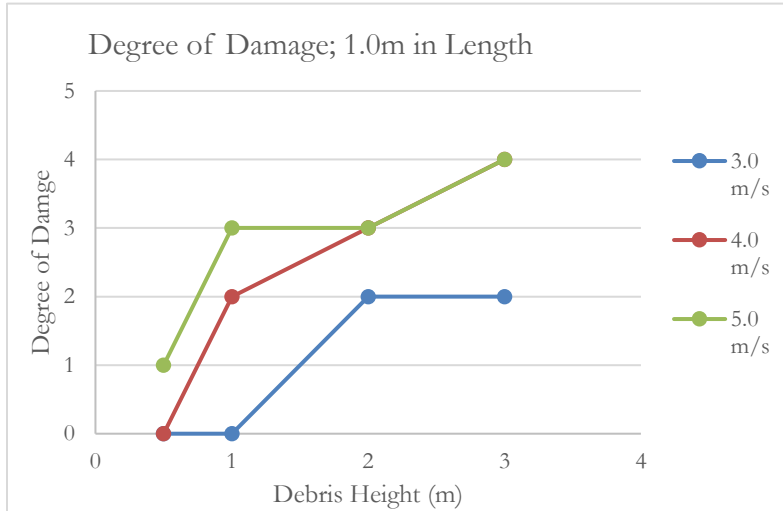
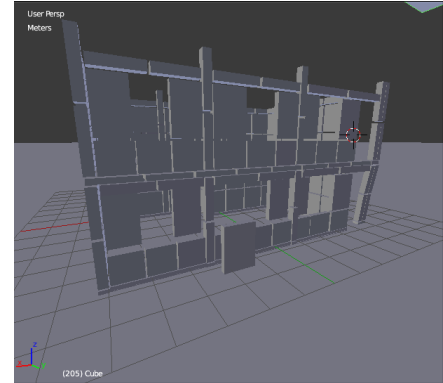
Figure 4.43a -4.43c: Adjusting the height of debris results in significant changes to the degree of damage at 1.0 meter; furthermore, increasing the velocity for debris heights over 1.0 meter significantly changes the degree of damage. (Top) The initial set up with a modelled element 11.0m in width and 1.0m in length and height for impact analysis; (Bottom) the simulated damage for a D2 classification at 4.0m/s. 1.0m video available at: https://www.youtube.com/channel/UCII_8TbvAsG2BZJENUtjcvg

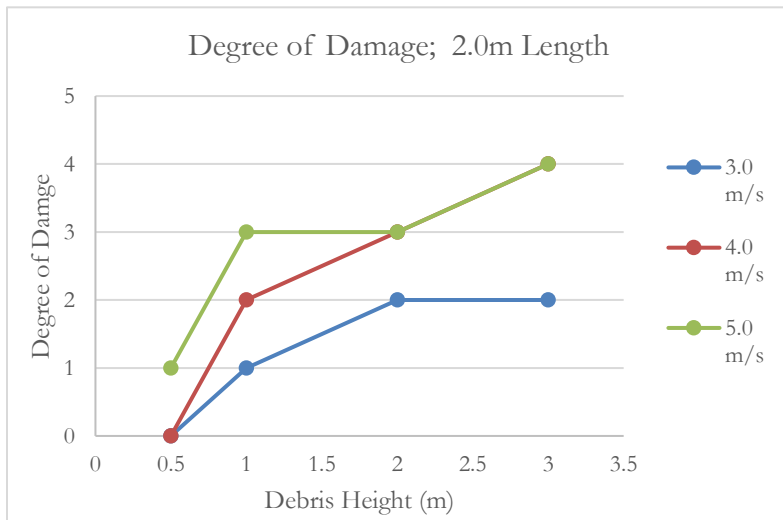
Figure 4.44a – 4.44c: Adjusted length of 2.0 meters, 4.0m/s Results in increased damage in the mortar walls and the columns on the right side of the building. 2.0m video available at: https://www.youtube.com/channel/UCII_8TbvAsG2BZJENUtjcvg

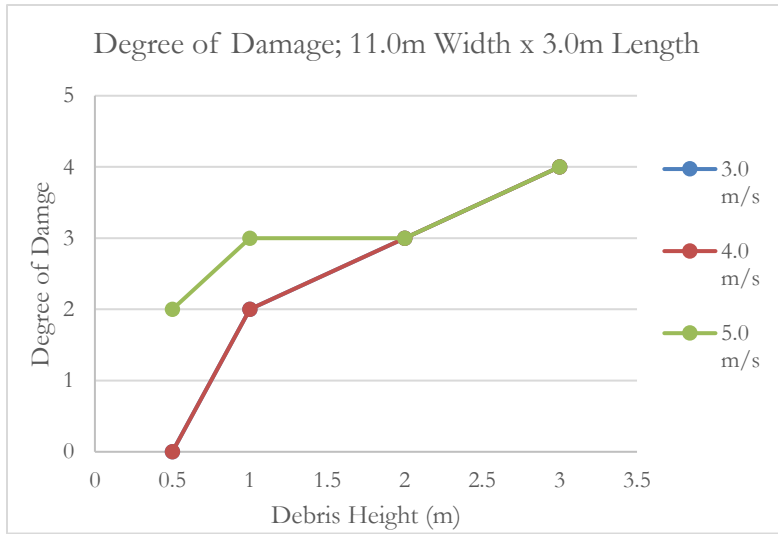
Figure 4.45a – 4.45c: 3.0-meter length results in similar damage for 3.0 – 4.0 m/s; however, the damage was observed in the unaffected walls, and the impact wall was significantly more damage. 3.0m video available at: https://www.youtube.com/channel/UCII_8TbvAsG2BZJENUtjcvg

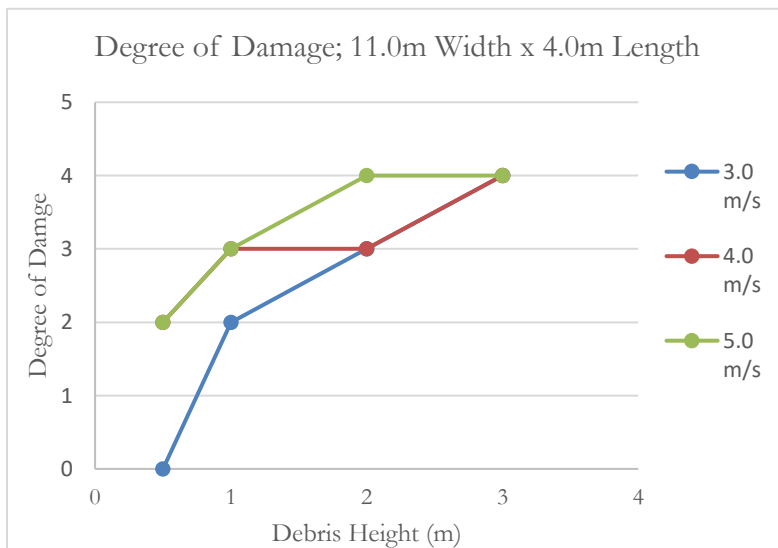
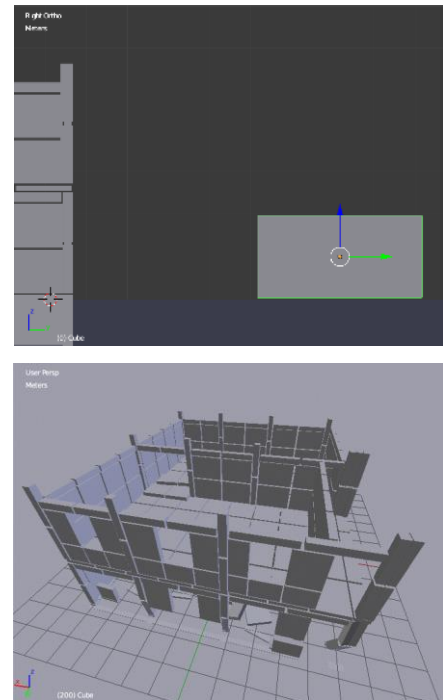
Figure 4.46a – 4.46c: A 4.0-meter length results in D2 damage for all velocities at a debris height of 1.0, and significant damage was observed in the entire buildings. Collapsed floors are observed on the second floor and all of the beams on the impacted wall have sheared from the foundation. 4.0m video available at: https://www.youtube.com/channel/UCII_8TbvAsG2BZJENUtjcvg

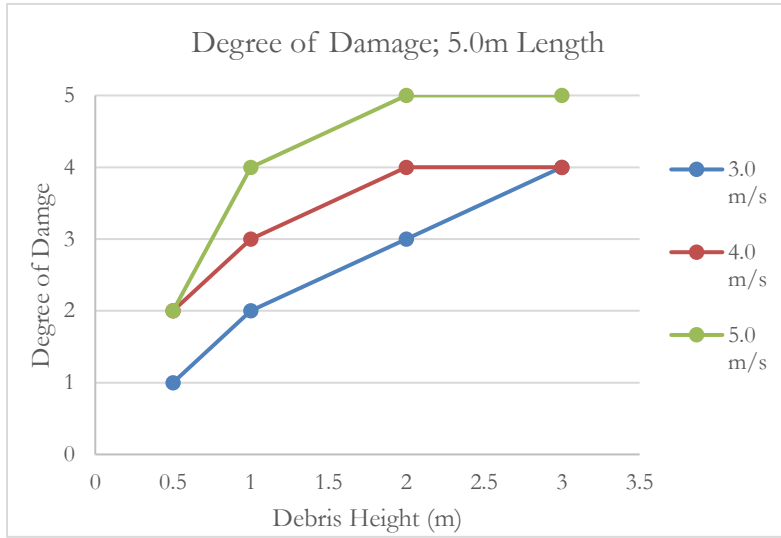
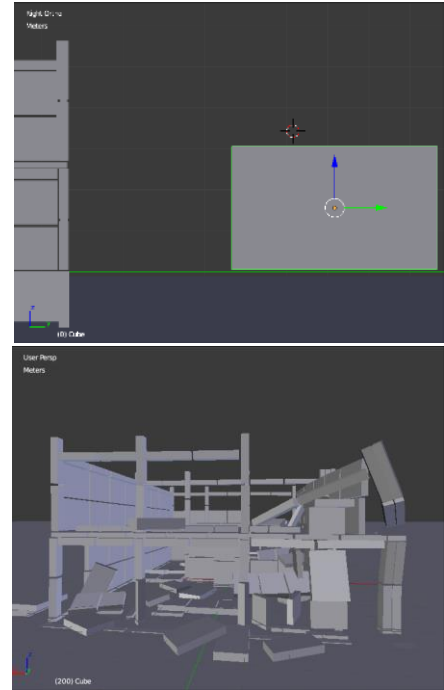
Figure 4.47a – 4.47c: A 5.0-meter length resulted in shallow impacting heights exceeding D1 damage, and 3.0-meter debris height exceeding D4. 5.0m video available at: https://www.youtube.com/channel/UCII_8TbvAsG2BZJENUtjcvg

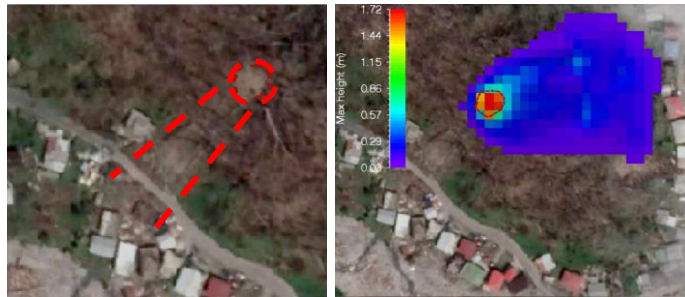
Figure 5.1 & 5.2: (Left) The expected flow direction during analysis of Building 1; (Right) the simulated flow direction

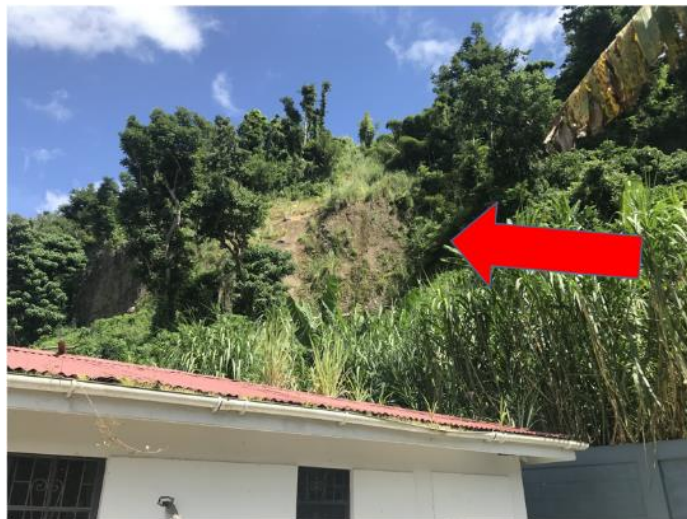
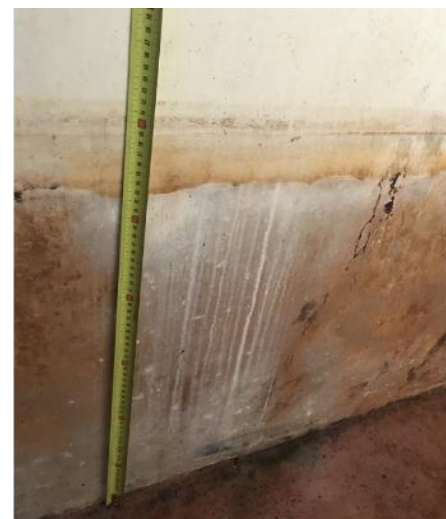
Figure: (Left) Debris slide erosion visible from the driveway (Right) Flooding stains along the walls

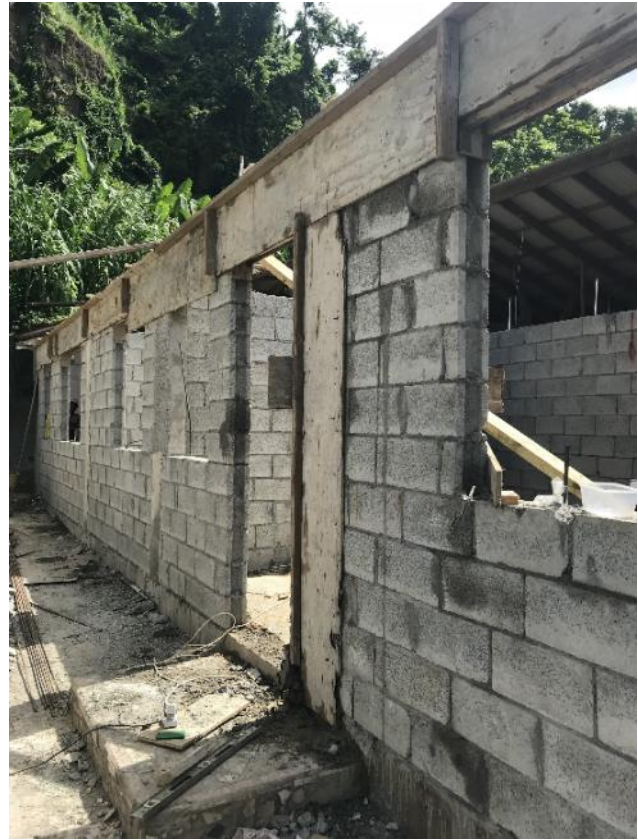
Figure: Building 10 being constructed to look the as it did before Hurricane Maria

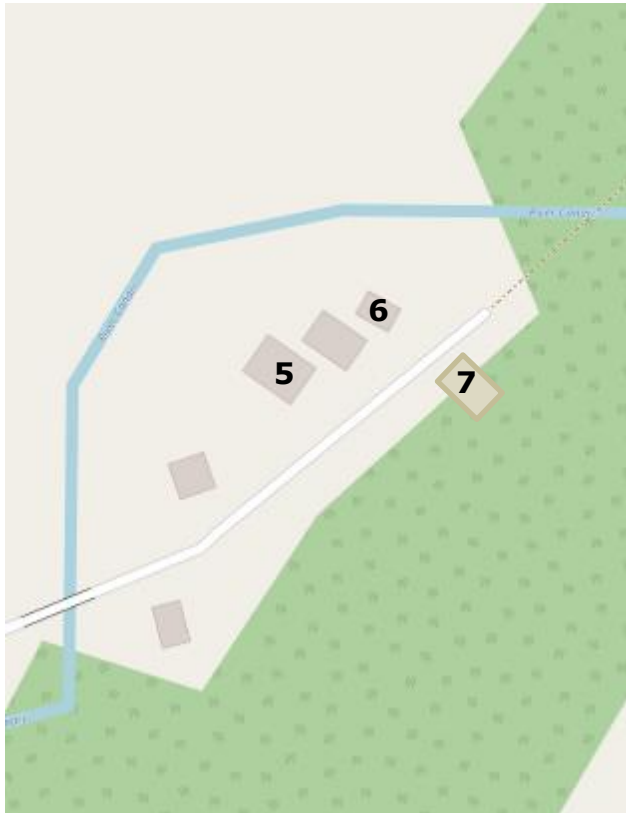
Figures: (Above) Plan view of Buildings 5-7. Bridge destroyed at dashed line crossing River Canari.

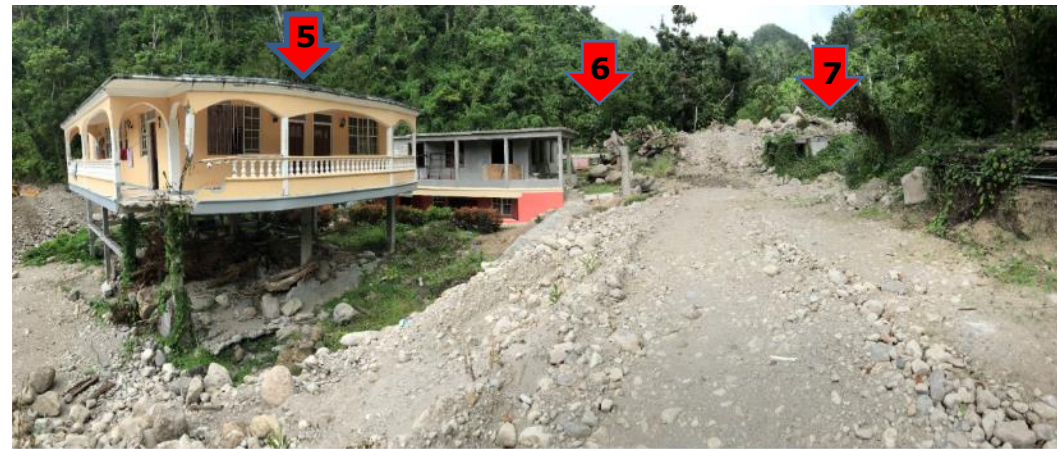
(Top-Right) Street view; Debris collapsed the retaining walls along the road, and vines hang from the damaged balcony of House 5.

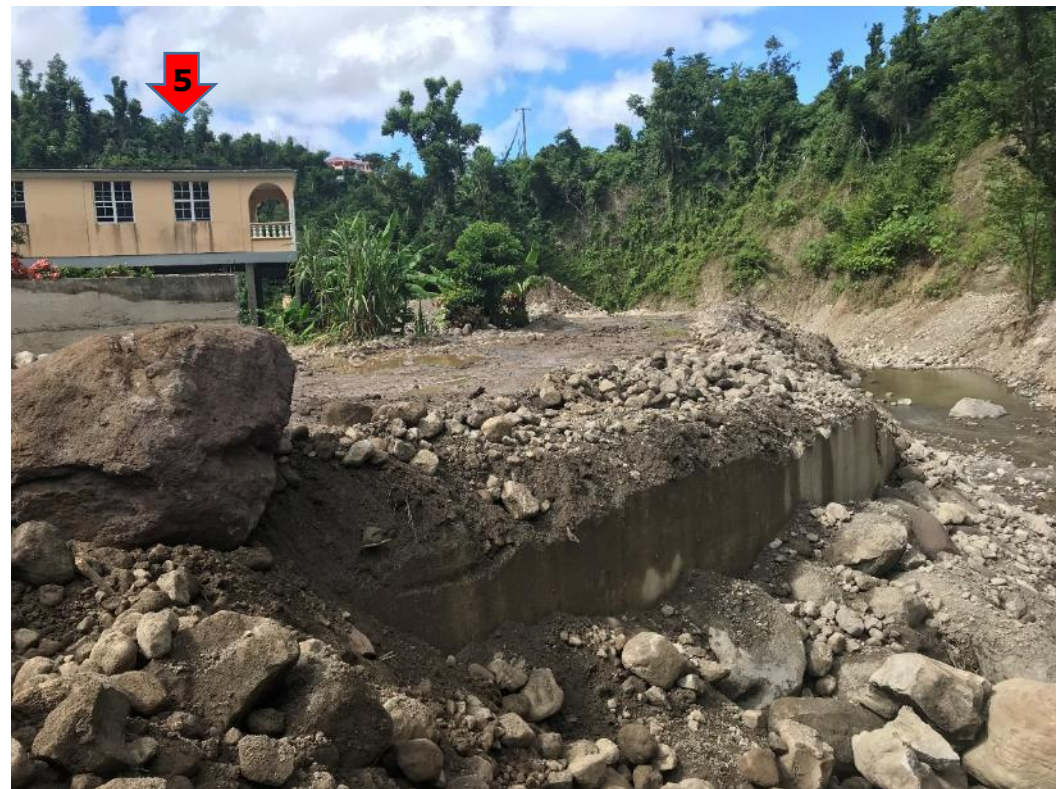
(Bot-Right) Two meter tall retaining walls along the river being excavated

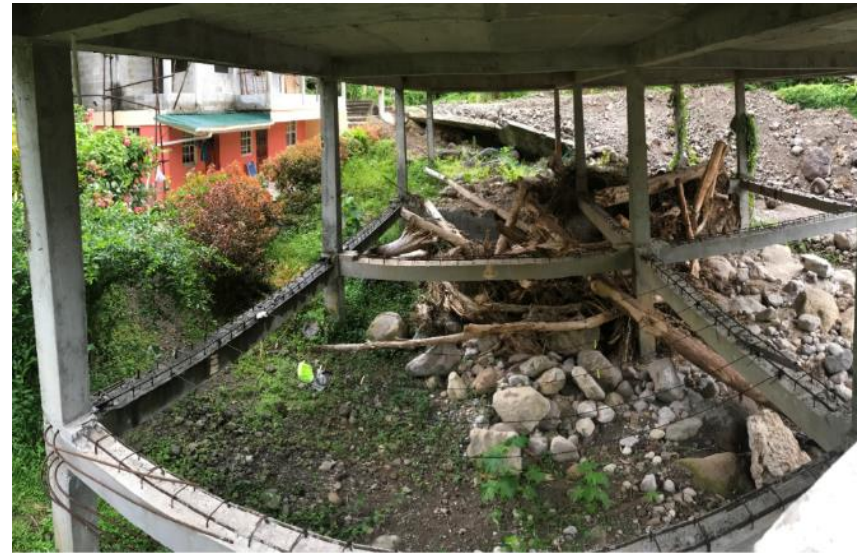
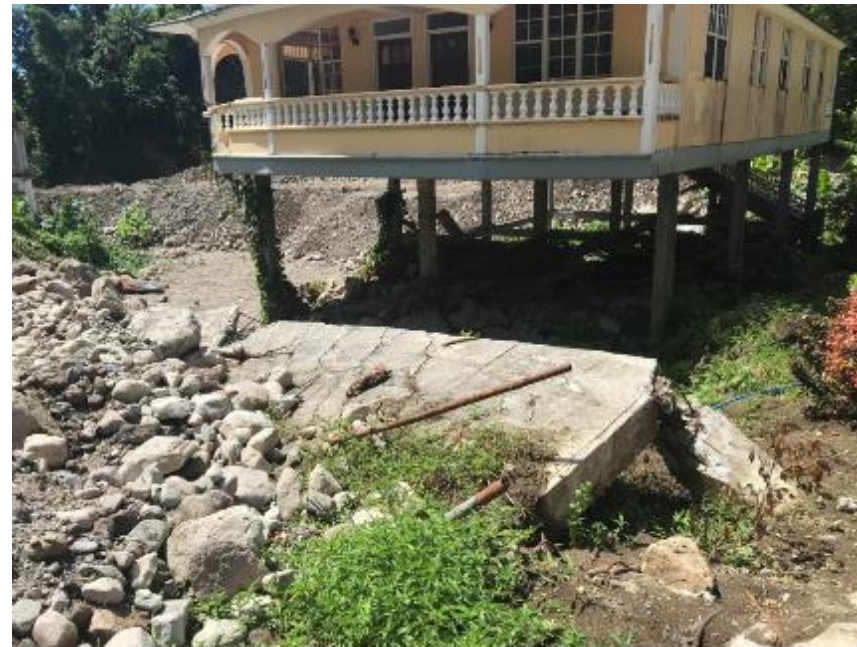
The reinforced concrete frame of the house in Assessment 5 is exposed on the ground floor. Large spruce trees, and boulders half a meter in diameter are scattered and tangled in the frame. There is only minor structural damage to the columns and beams; such as chips in the concrete. The rebar in Figure 3.18 is deformed in the direction of flow from sediment and water pressure greater than the bending strength of the reinforcement. In Figure 3.16 the water level and sediments damaged the balcony. The reinforced column, concrete slab, and decorative railing, now tangled in vegetation, have minor structural and non-structural damaged. The retaining wall (Figure 3.19), and neighbouring houses, shielded the house from a direct impact.

Figures 3.18 & 3.19: (Top) Standing on the stairs looking under House 5. (Bot) Standing from the road, the reinforced concrete retaining wall collapsed in front of House 5.

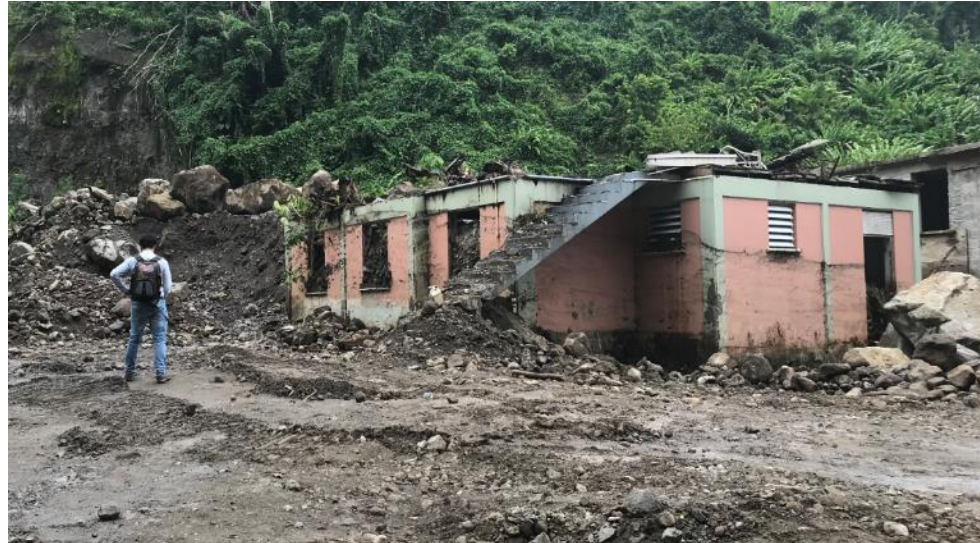
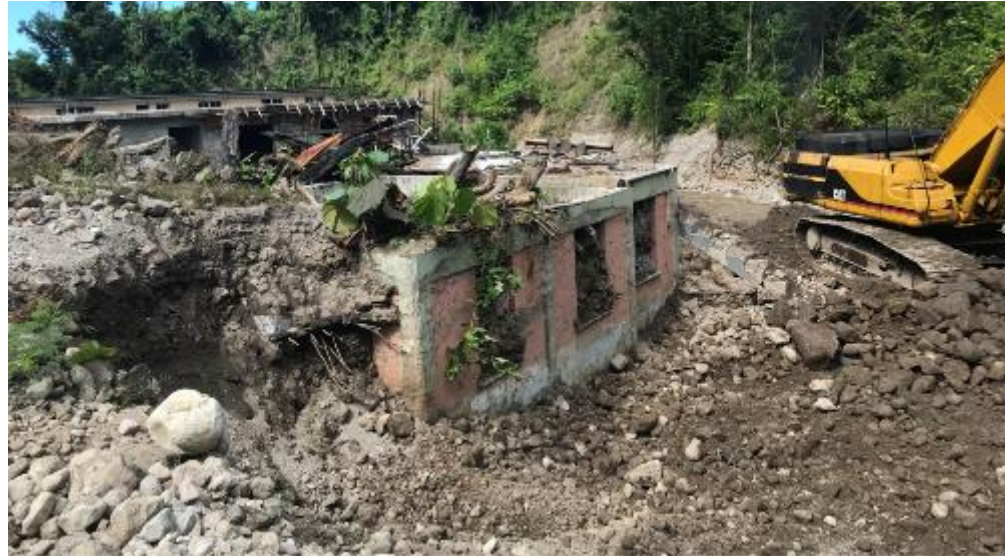
Assessment 6 is furthest upstream and closest to the river. After the river dammed, sediments accumulated along the north-east façade of the house (Figure 3.20). The sediments reached the top of the ground floor collapsing a timber framed second floor and attic. The remains were either buried or carried away. The weight of sediments and water collapsed the roof of the ground floor (Figure 3.21). Sediments are distributed in every room to the ceiling, except near the back door where sediments continue to flow out the house. The house is in the process of being excavated from debris. Unearthed sections of the home show no significant cracks or breaks other than the collapsed roof; possible due to a gradual increase in pressure rather than a sudden high intensity impact on the house.

Figure 3.20 & 3.21: (Top) Standing from the river bed on excavated ground. (Bot) Standing on the upstream side of

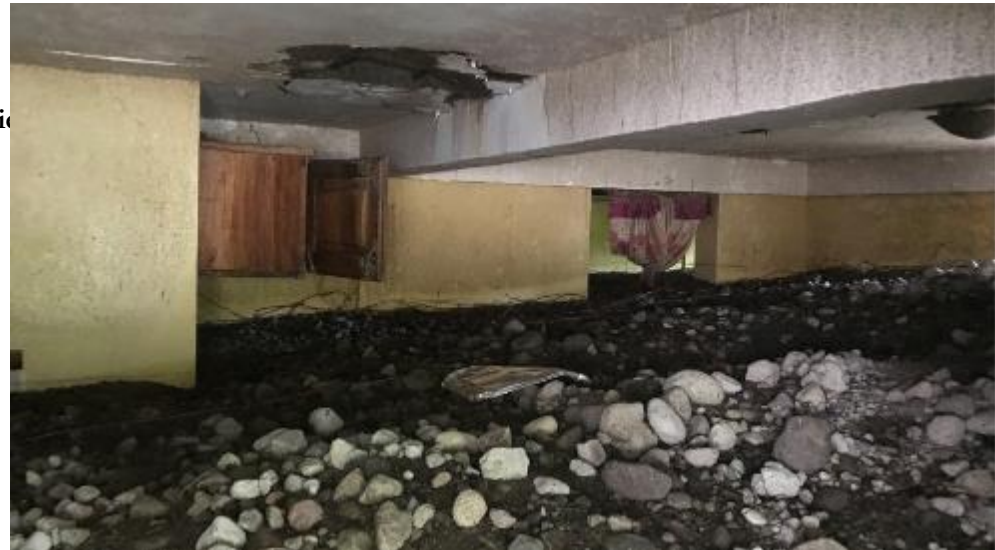
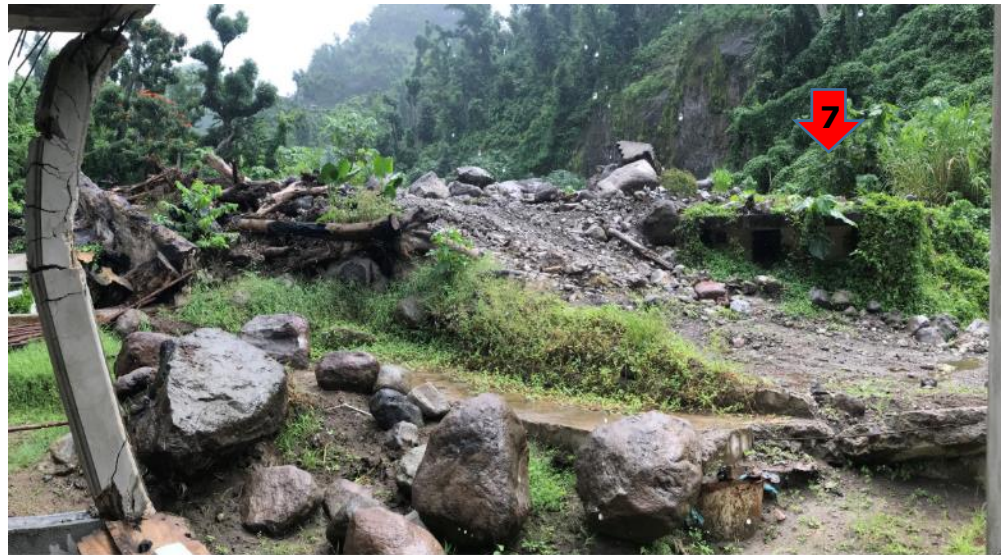
The damage in Assessment 7 is similar to Assessment 6. An additional timber framed floor collapsed and floated away. The roof of the house is not collapsed; however covered in debris and vegetation. The house is filled with an evenly distributed amount of debris (Figure 3.22). Additionally, less debris excavated around the house limits accessibility. The retaining wall between the house and road is either buried or destroyed. Larger boulders surrounding Assessment 7 and the road, are accumulated around damaged columns of the neighbour (Figure 3.23). Other than the house being partially buried, the exposed frame and walls of the ground floor have no significant damage. The ceiling damage in Figure 3.22 is not noticeable from the roof.

Figures 3.22 & 3.23: (Top) Crouched in the doorway of House 7 looking into the largest room. (Bot) Standing from the neighbour's porch, between Houses 5 & 6.

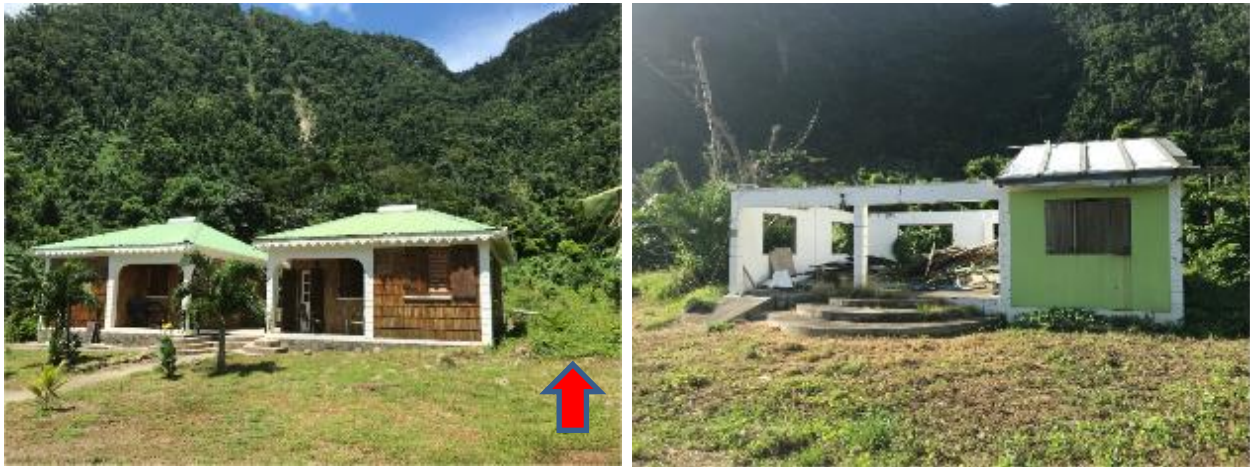
Figure 3.32 & 3.33: (Left) Assessment 8, at Site 21, has been excavated in the front but accumulated debris is left over on the right side; indicated by red arrow (Right) Assessment 9 is a storage facility, the boarded window is part of an inaccessible room

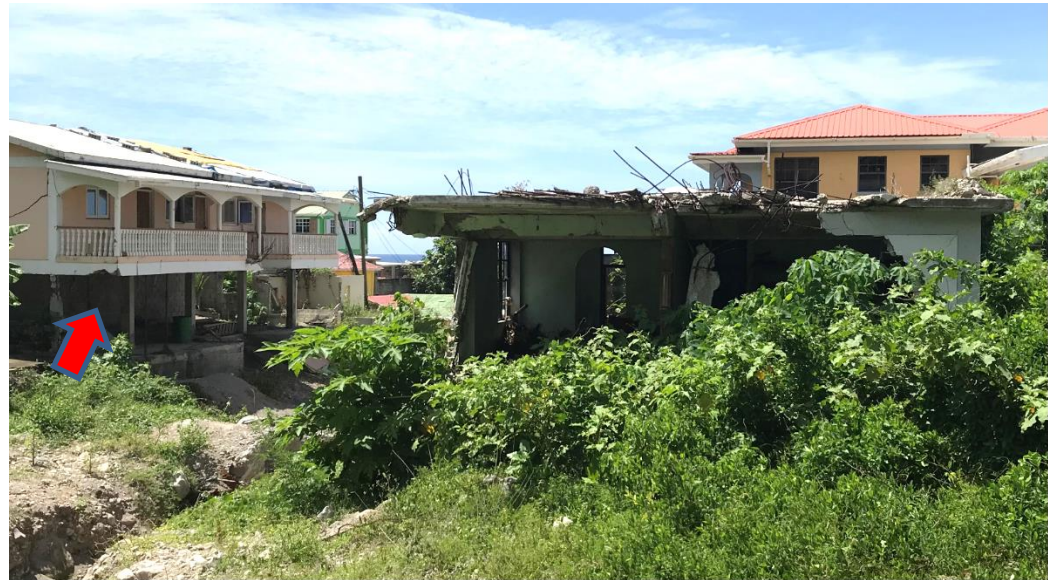
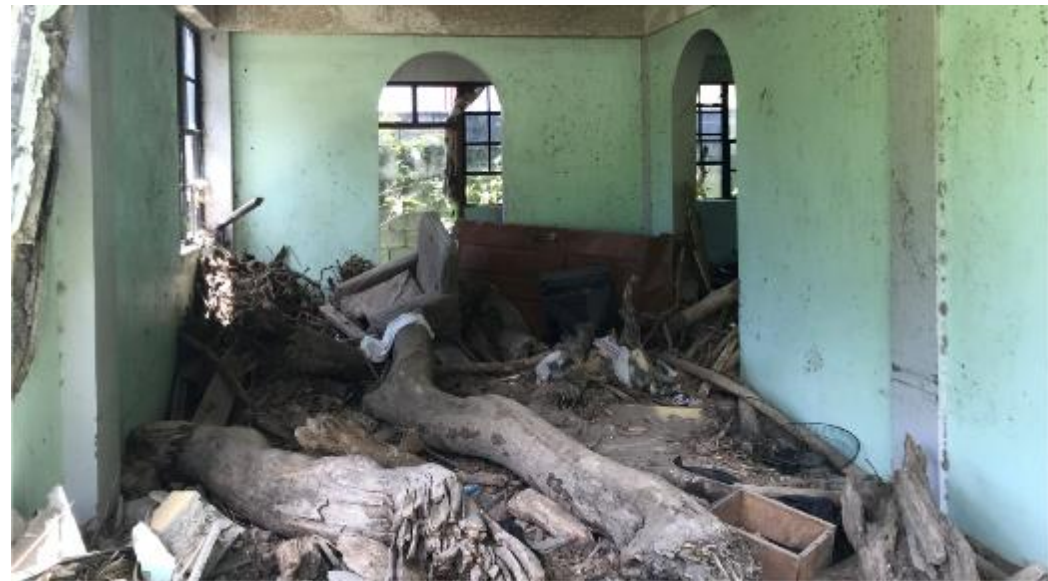
The upstream façade (east wall) of the house in Assessment 3 collapsed from the pressure of flooding, trees, and debris. The owners of the yellow house across the sediment stream recall the water level reaching the balcony of their home (Figure 3.36). There are columns and reinforcement on the roof of the house damaged; however, there is no evidence of an additional collapsed floor. The wall parallel to the stream bed is partially cracked through the column at the SE corner. The damage is irreparable and will require demolition. Destroyed furniture is mixed with the accumulated trees and debris in every room (Figure 3.37).

Figures 3.36 & 3.37: (Top) Collapsed wall of Assessment 3 and neighbour's damaged balcony from water level indicated with red arrow; (Bot) standing in the opening of Assessment 3, trees meters long extend to the back of the house.

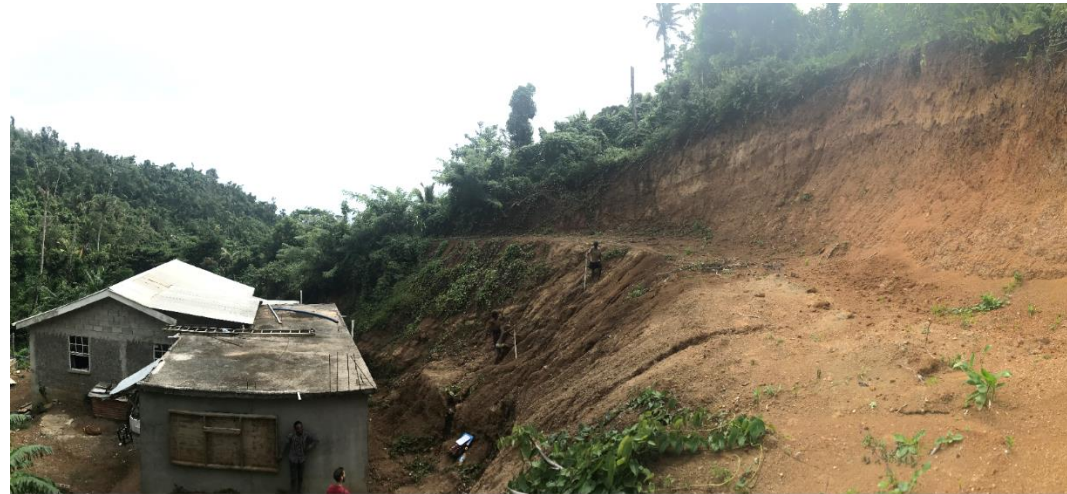
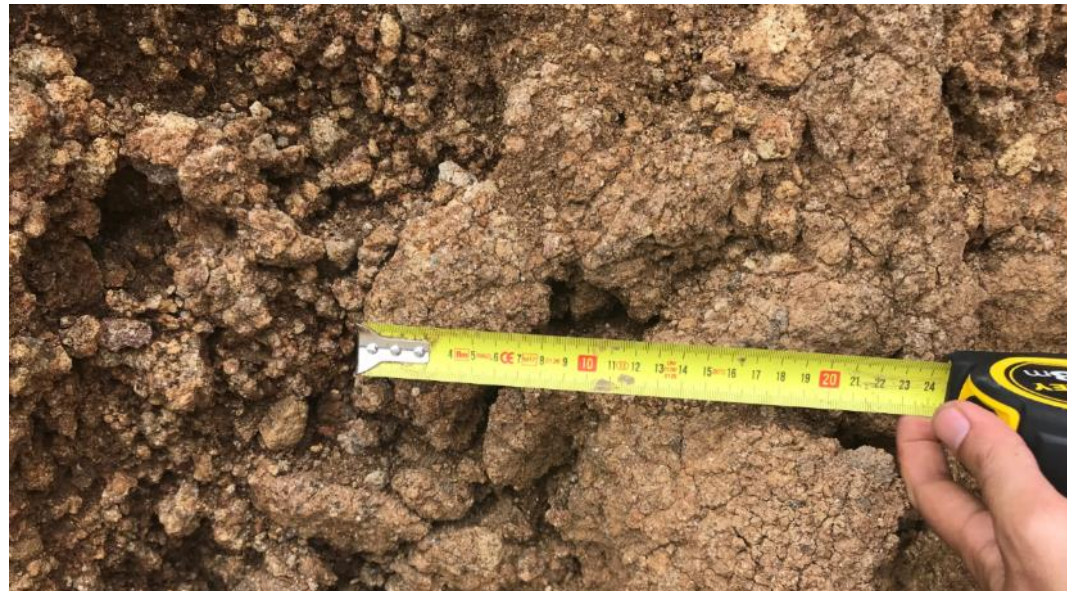
The owners of the house in Assessment 4 described the event; a debris slide occurred on the adjacent slope (Figure 3.40), accumulating around the house and on to the roof. Before Hurricane Maria, the owner constructed retaining walls between the stream and the house, also, boarded the windows facing the hill. A hurricane, prior Hurricane Maria, triggered a similar slide and broke the windows of the house. Debris spilled into the rooms, therefore, the owner boarded the windows before Hurricane Maria. The debris slide is composed from a pyroclastic weathered ash deposit (Figure 3.41). The lateral extent wraps approximately 30 meters around the house, and has a slope length 20 meters from the house to the vegetation on top.

Figures 3.40 & 3.41: (Top) Excavated slope at Assessment 4 after debris slide. (Bot) Weathered ash soil of varying sediment sizes at Assessment 4.

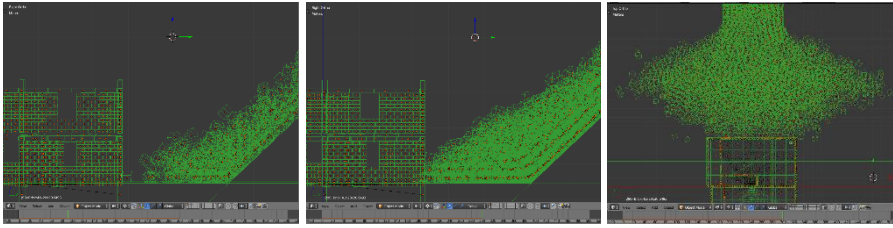
The first soil element to reach the building knocked a brick out of the wall (Shear = 0.5 N/mm²), and the geometry of the slide is slightly different due at the moment of impact in comparison to the passive body model because the computer has to run more calculations. Therefore, the resolution of the house will be reduced by converting the bricks on the side, interior, and front wall into slabs (unbreakable elements) with mortar strength constraints where touching columns and beams. Additionally the ground foundation rigid bodies added to the simulation in the preprocessing steps, add 0.1 meter of foundation and lowered the ground plane below the XY plane which increases the distance from the building to the slope.
