Damage and Vulnerability Analysis of Debris Slide Impacts to Buildings through Analytical Methods

AARON ORR
March, 2019

Thesis submitted to the Faculty of Geo-Information Science and Earth Observation of the University of Twente in partial fulfilment of the requirements for the degree of Master of Science in Geo-information Science and Earth Observation.

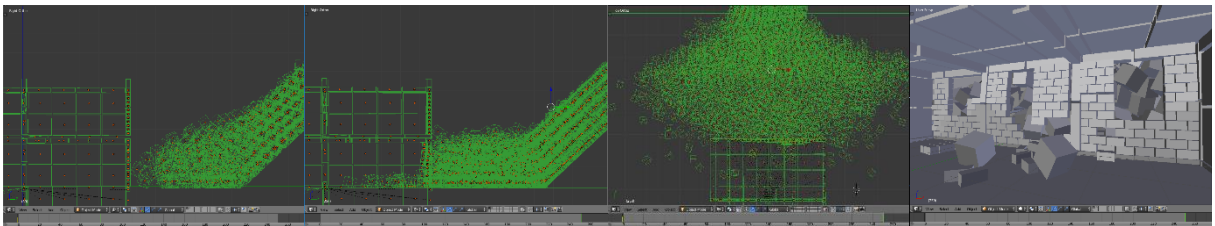
The simulation ran for a total of 250 frames; however, the slide was significantly slowing down. Several bricks were immediately sheared from the wall, and more continued; the columns are flexed. The debris height is ~2.5 meters.
